PT 658 GETS A ROOT CANAL by Don Cameron

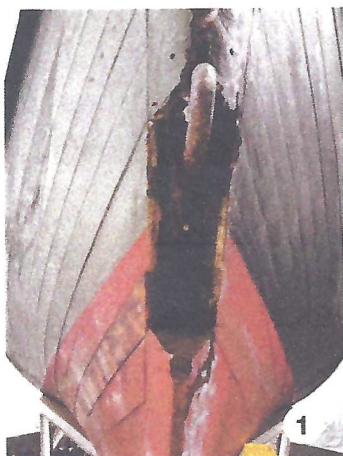
Upon inspection, we did indeed find soft wood and rot all around the front tow eye (Photo 1), necessitating the removal and replacement of the damaged wood in the affected area. It's just like what a dentist does to repair your teeth -- the PT Boat needed a "root canal" job.

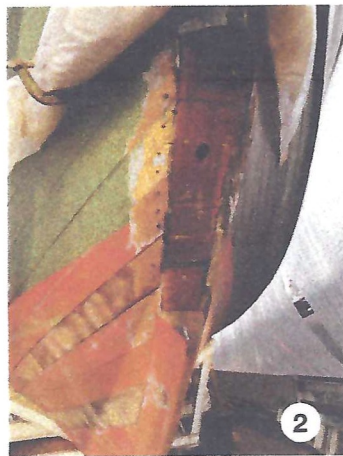
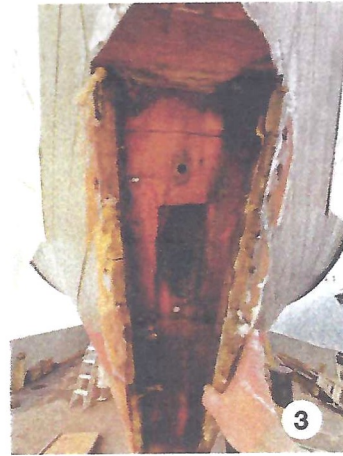
The bow stem of PT 658 is comprised of three solid mahogany beams that are about 18 inches wide and 12 inches thick, fastened together to form the shape of the bow (Photos 2 & 3). Using a 3" Forstner bit, we drilled out all the rot. This left a gaping hole about 30" long and up to 8" deep. To rebuild where the wood was removed, we used Sapele, a hardwood similar to mahogany. We installed multiple pieces of Sapele with epoxy to fill the deepest void (Photo 4). The new wood was then belt sanded to line up with the leading edges of

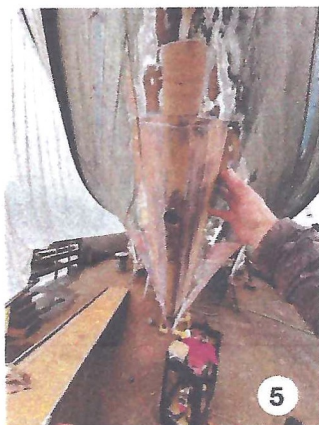
the hull planks to re-form the bow's shape. The next step was to further build up the triangular point of the bow, by cutting and bending multiple pieces of planks (Photo 5).

Sapele wood does not bend easily. Using wood screws and epoxy to fasten half-inch-thick planks, we found we were able to bend the wood enough to form the radius of the bow. It took eight planks; each cut a little smaller than the next to create the bow's final shape. Once the epoxy cured on each plank, its screws were removed, and the next piece was set in place. After all the pieces were set and the epoxy fully cured, the rough edges were shaped and sanded smooth (Photo 6). Finally, we applied bottom paint under the waterline, and primer and finish paints above the waterline (Photo 7).
